TYPICAL PATCH REPAIR

DRAWING No: DGS-325-1

DRAWING TITLE: MEMTECH - TYPICAL PATCH REPAIR

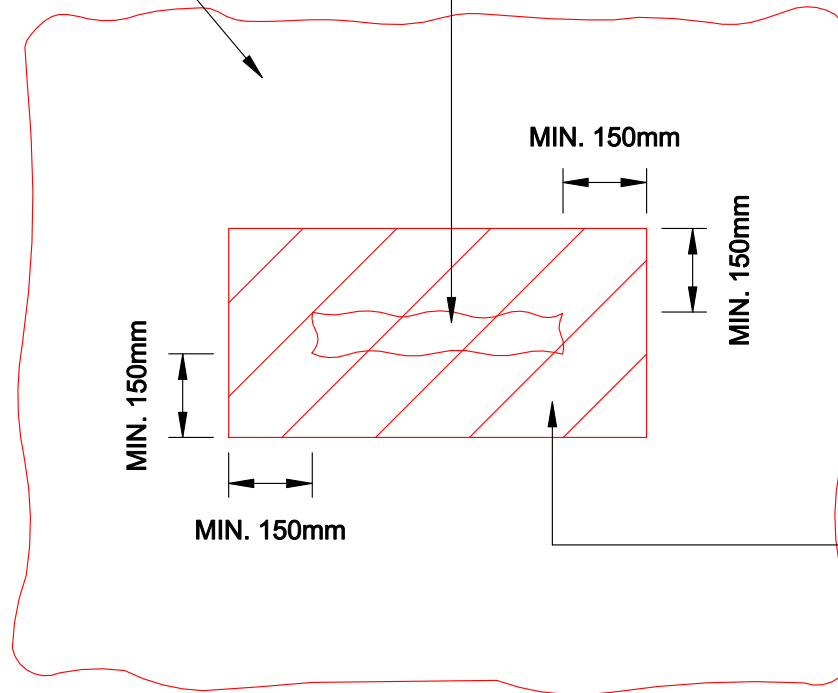
MEMTECH TITAN / R1 / M1 / MEMBRANE

CUT OR DAMAGE TO MEMBRANE

MEMTECH TITAN / TITAN TANK / R1 / M1 /
PATCH TO EXTEND MINIMUM 150mm FROM
DAMAGED AREA IN ALL DIRECTIONS

JOINTS TO BE HEAT WELDED / DOUBLE SEALED
WITH MEMTECH GAS TAPES

Memtech Titan provides both a waterproof membrane and Hydrocarbon
and VOC barrier in accordance with BS 8102 (2009) and BS 8485: 2015
